Seal Rock Water District

General Manager's Report:
 Board Meeting February 11, 2016

● OCEANIA DRIVE EMERGENCY DISTRIBUTION SYSTEM REPAIR:

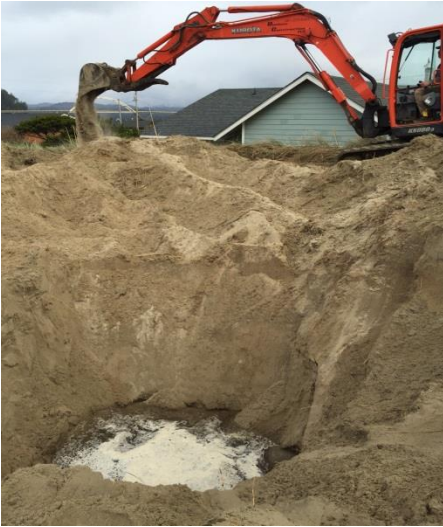
Lowering Sand Dune for safe Access:

Crews worked through the day to reduce a sand dune to expose the 6-inch water main located below 20-feet of sand. After inspecting the break in the pipe it's apparent that the pipe was unable to support the amount of weight, and sustained a stress fracture causing the pipe to separate.

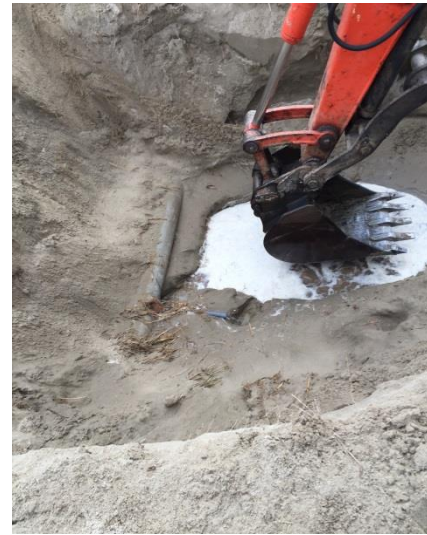
Exposing Pipe 20-feet deep:

Due to the amount of time needed to remove sand to safely complete repairs, property owners in the affected area went without water (this included the entire spit) for an extended period of time. Ultimately, due to the depth of sand crews had to bring in a larger piece of equipment to safely access the pipe. Accessing the District's system in this area is vital to our efforts to maintain reliable service to this community.

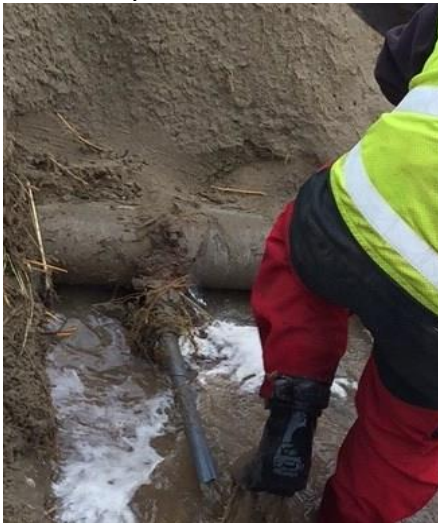
Photo on the left shows a crack in the pipe just to the right of the service lateral connection. This pipe section dropped by as much as 3/4-inch:

While we appreciate everything the County is doing in an effort to support the community in the development of a sand control district in this area. This waterline break is one of 4-line breaks in this area in past 12-months. Pipe failure in other areas along Oceania Drive where larger sand deposits exist is imminent. This includes deposits made by property owners that continue to move sand onto the public right-of-way on a weekly bases. District staff has requested that the County consider providing a general mailer to the property owners along Oceania Drive regarding risks associated with dumping sand in the public right-of-way.
